Inspection Report

Minerals Regulatory Program

Mine Name: Sage
Operator Name: Butt Mining Company

Permit number: M0370058
Inspection Date: June 13, 2006
Time: 5:45-6:00 PM

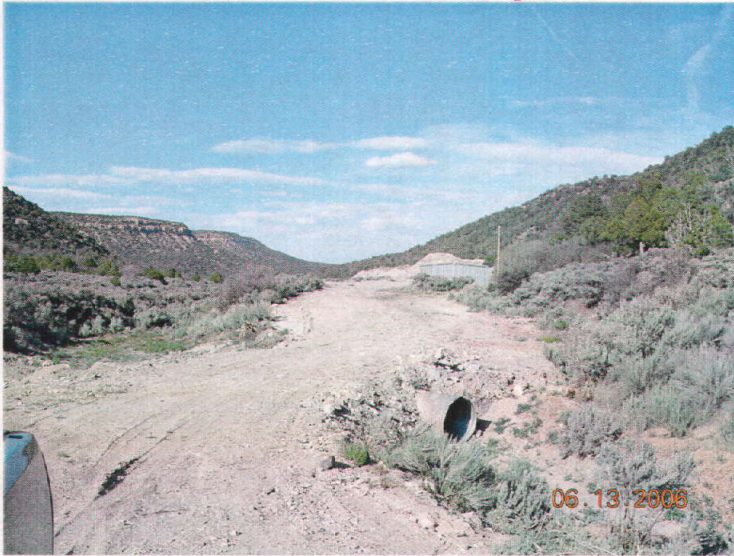
In the report for the previous inspection, I suggested that a culvert be placed where the access road crosses the stream not knowing that a culvert was there (Photo 1) and that the inlet and outlet needed to be cleaned. This has been done.

Photo 1. The culvert has been cleaned; it was completely covered at the last inspection.

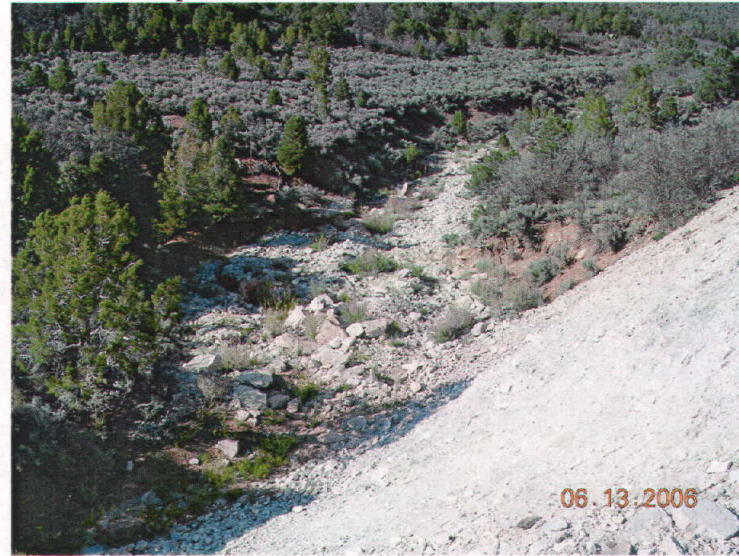
Photo 3. The berm should help keep material from the waste pile from entering the drainage.

The operator and the Division need to monitor the berm around the edge of the waste pile for maintenance problems.

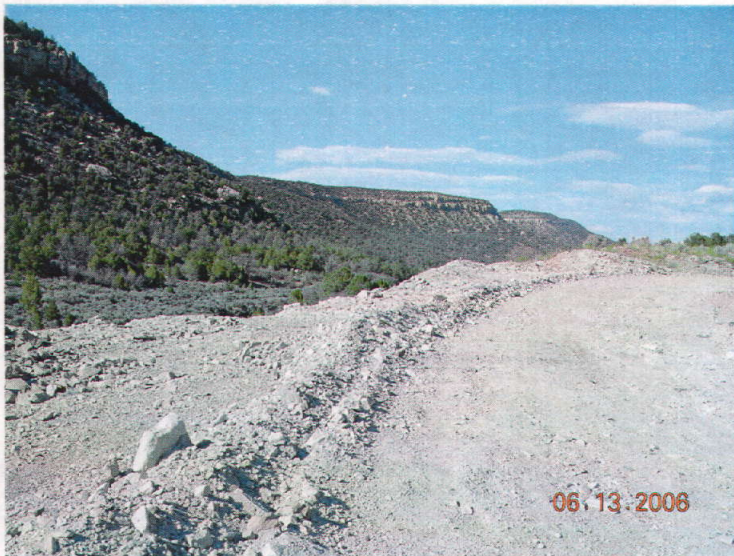
The operator has built a berm around the edge of the waste pile (Photo 2) in an attempt to keep runoff from the top of the pile from eroding the sides. There will still be some erosion off the sides of the waste pile.

Photo 2. A berm has been built around the edge of the pad.

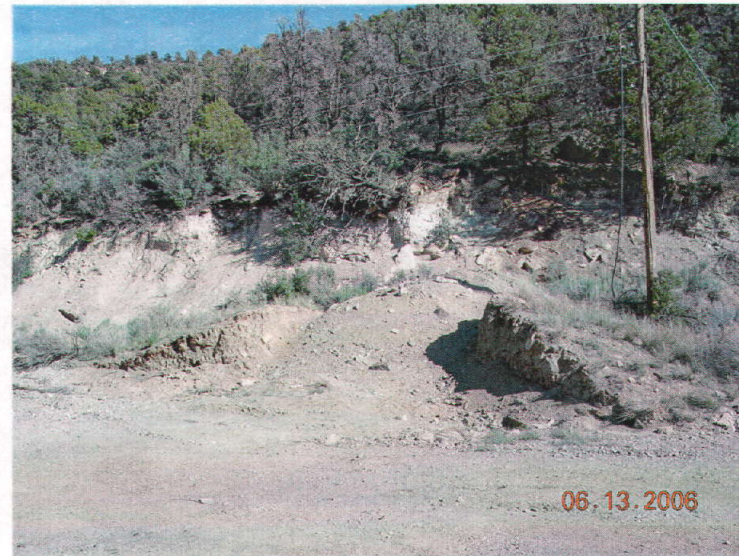
When I inspected the mine in August 2005, the portal was open, but it has now been backfilled (Photo 4).

Photo 4. The portal has been backfilled.
